**bit**  
internet technology

## Incident report, network error March 7th 2016

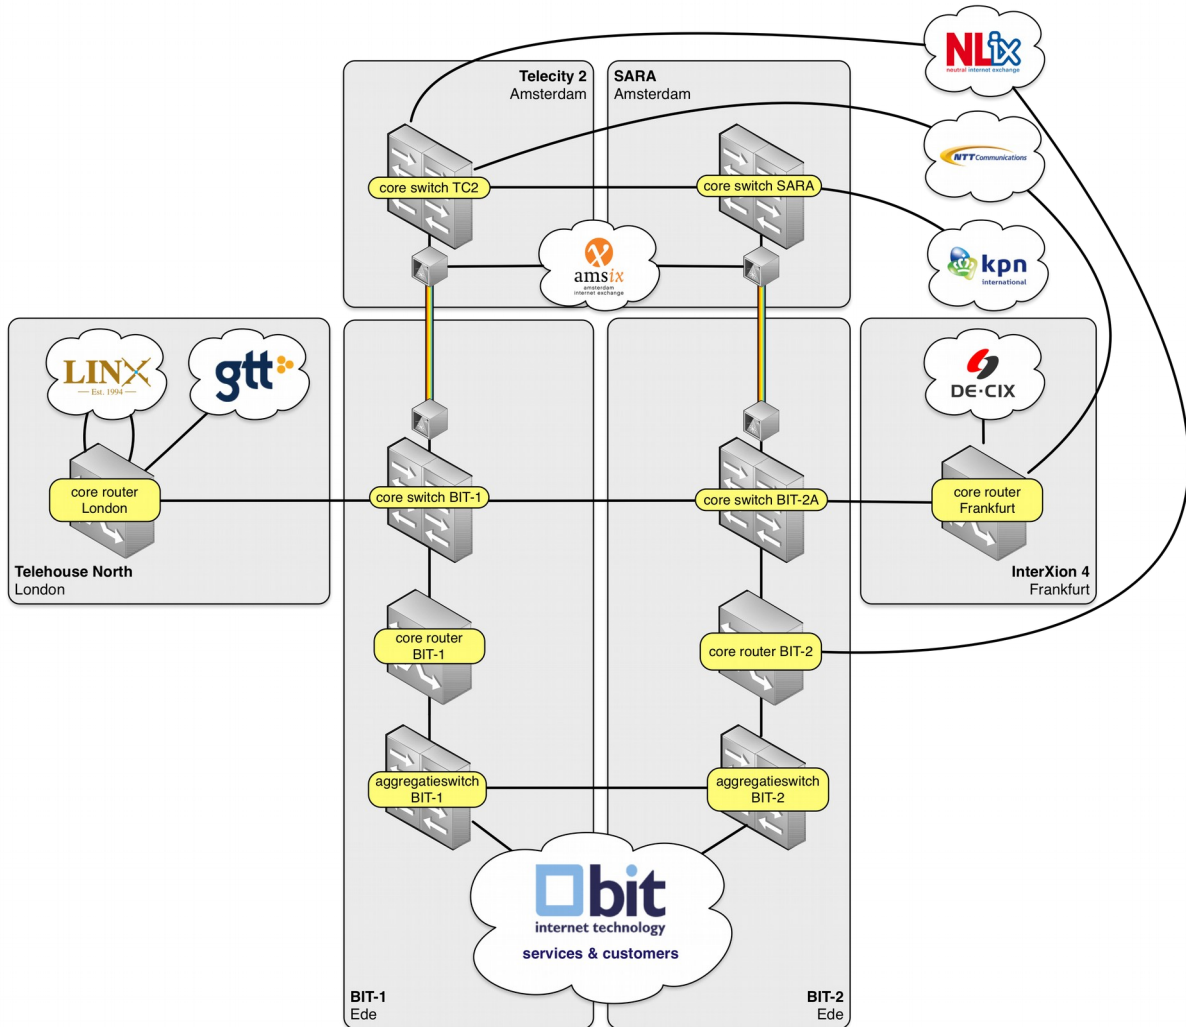
For a correct image of the incident, it is important to have a clear idea of BIT's network architecture. The diagram below depicts the most important components in BIT's core network. The components in BIT-1

and BIT-2 are simultaneously active, failure of one of the components automatically means that all traffic that should go through that component, is rerouted. This goes for both the switching and the routing. There is a core ring with loop protection between the data centers in Ede and Amsterdam. Failure of one of the core switches or one of the paths will lead to the use of an alternative path.

High CPU load on the core switch in BIT-2A leads to a loop on the core network. As a result of that high CPU load, loop protection on the switch is not functioning as it is supposed to. In turn that results in all traffic on that switch being sent to all ports and the disabling of the connections on the switch. The paths between BIT-2A and Frankfurt and SARA (Amsterdam) will not be available if this happens. This only has direct consequences for a number of VLAN's between BIT-2A and Amsterdam and for a part of the access services provided over the Tele2 network.
