**bit**  
internet technology

## Incident report, network error March 7th 2016

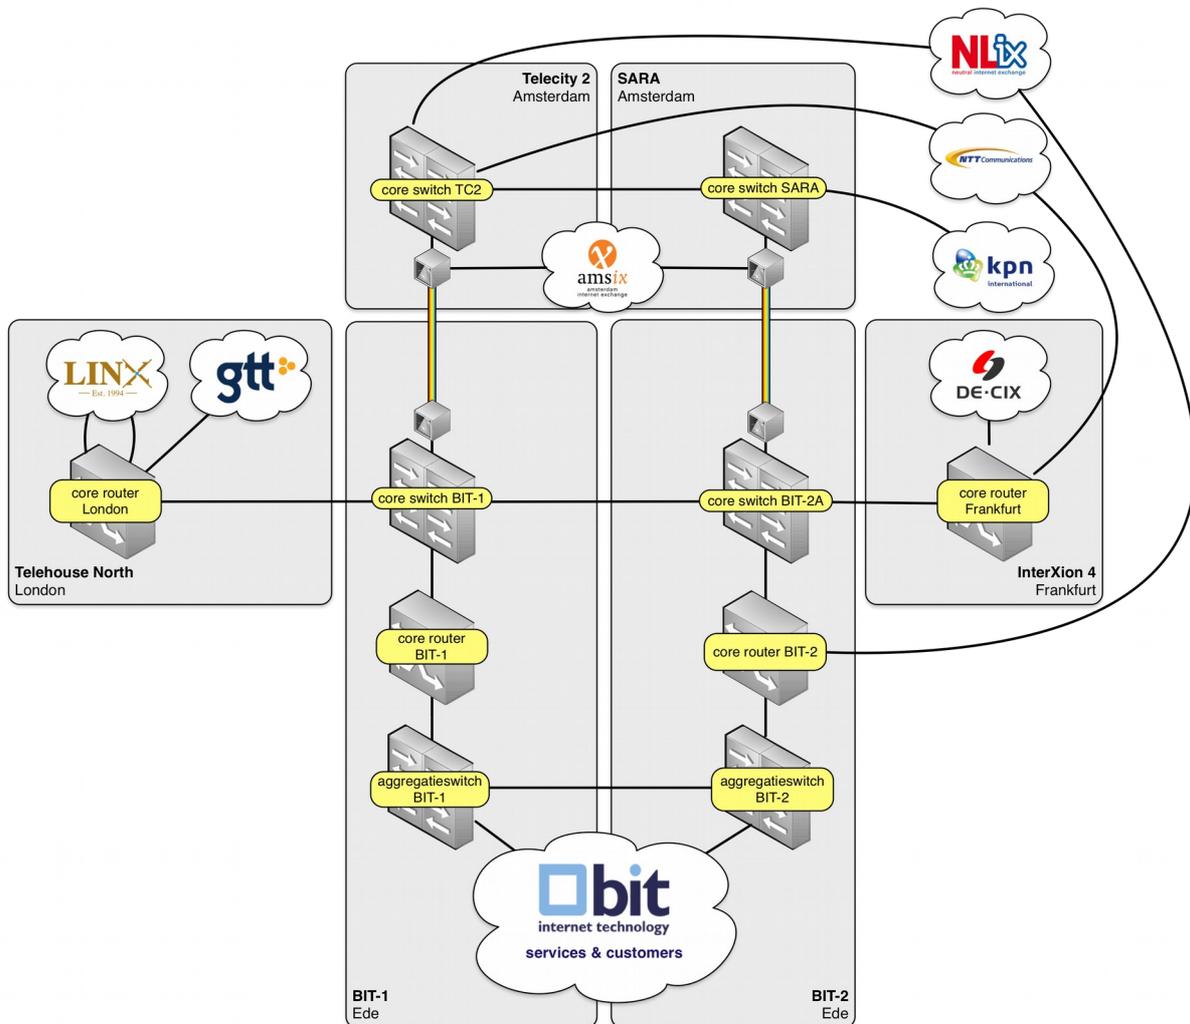
For a correct image of the incident, it is important to have a clear idea of BIT's network architecture. The diagram below depicts the most important components in BIT's core network. The components in BIT-1 and BIT-2 are simultaneously active, failure of one of the components automatically means that all traffic

that should go through that component, is rerouted. This goes for both the switching and the routing. There is a core ring with loop protection between the data centers in Ede and Amsterdam. Failure of one of the core switches or one of the paths will lead to the use of an alternative path.

High CPU load on the core switch in BIT-2A leads to a loop on the core network. As a result of that high CPU load, loop protection on the switch is not functioning as it is supposed to. In turn that results in all traffic on that switch being sent to all ports and the disabling of the connections on the switch. The paths between BIT-2A and Frankfurt and SARA (Amsterdam) will not be available if this happens. This only has direct consequences for a number of VLAN's between BIT-2A and Amsterdam and for a part of the access services provided over the Tele2 network.

Because of the changes in the core network, the core routers have to alter a great number of routes. The routers' CPUs appear to be a bottleneck here, leading to discrepancy between the routing and forwarding tables of the routers for a considerably long time. This means that the traffic is not arriving at its destinations, but that it gets lost and that the rest of the internet is unable to reach the BIT network anymore. Without the CPU problems of the routers, the impact would have been contained to a possible short interruption of existing connections.

- The access procedures to [www.bit.org](http://www.bit.org) have been altered to allow faster access to be able to report incidents quicker.

- There has been a lot of contact between our distributor and the fabricator of the routers to place routers with much more CPU capacity on very short notice. An incident analysis has been conducted with the fabricator's specialists to determine the exact cause of the CPU load.
- Partly due to the fabricator's recommendations, several adjustments have been made in the network configurations to lower the load on the core routers without compromising quality and availability of the network. Even though these adjustments lower the load on the routers, it is not a permanent solution. We expect more of these adjustments in the coming weeks.

- Based on the incident analysis, the fabricator suggested replacing routers with more and more powerful CPUs. The fabricator's simulations showed that this new type of router performs much better. However, these routers are not immediately available. The fabricator expects to be able to supply temporary routers of the same type within two weeks.
- In expectance of these routers, BIT's network engineers are preparing configurations.
- As soon as the routers can be delivered, BIT's network engineers will work on testing and configuring them with the highest priority. They expect to need two workdays to do this. Emergency maintenance will be announced to replace the two core routers one by one. A rollback scenario will be developed to switch back to the old routers in case of unforeseen problems.
